Historic Road Bridges

Fingal County Council

Volume 2
Built Heritage &
Ecological Inventory of Bridges

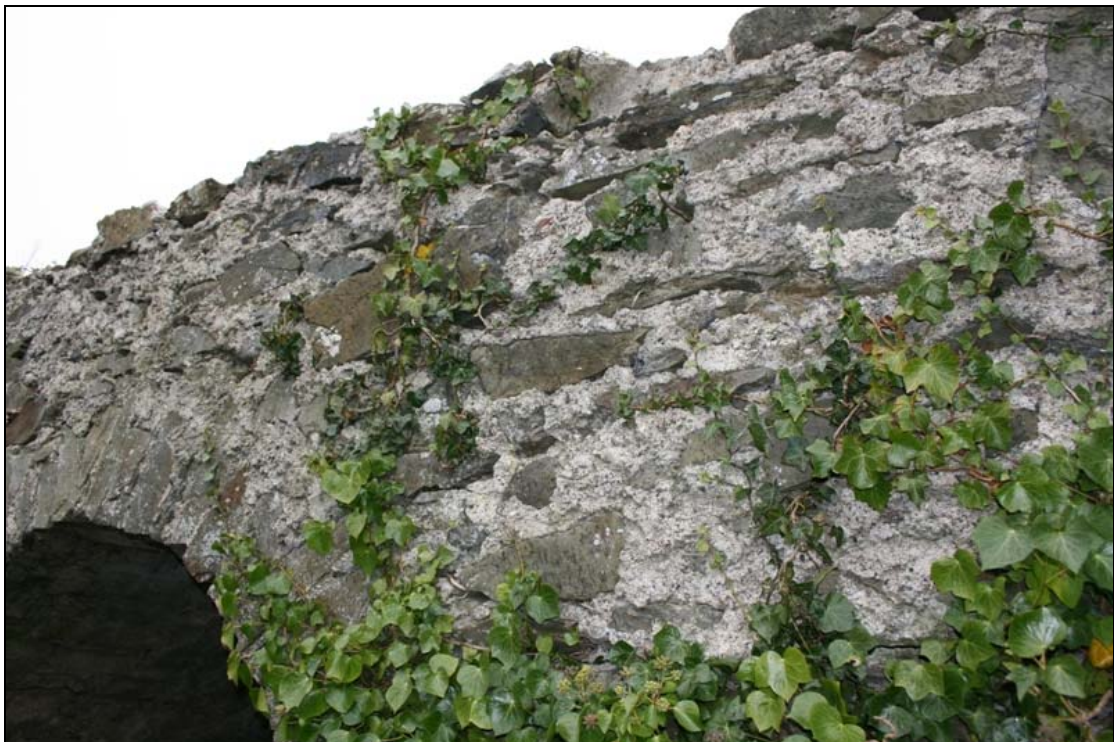
FHBS-10-BH-05 ~ Detail of stone and jointing mortar on exterior of south parapet

rainwater.
Condition (matrix/mortar)	Generally good but with selective pointing required in areas, notably at base of central pier which stands in water.
Condition (soffit)	Good
Grouting or spray concrete?	No
Grouting or spray commentary	n/a
Accessibility	Accessible from all sides
Built heritage photographs	FHBS-10-BH-01 ~ South upstream elevation FHBS-10-BH-02 ~ North downstream elevation FHBS-10-BH-03 ~ South parapet from top of bridge FHBS-10-BH-04 ~ North parapet from top of bridge FHBS-10-BH-05 ~ Detail of stone and jointing mortar on exterior of south parapet FHBS-10-BH-06 ~ Soffit of eastern arch from south FHBS-10-BH-07 ~ View downstream to north from west abutment FHBS-10-BH-08 ~ View west over bridge
Name of Built Heritage Field Surveyor	Eamonn Hunter
Date of inspection (Built Heritage)	29-10-08
Built heritage commentary	This structure appears to be in very good condition with little alteration since its construction. While its disuse has resulted in a lack of structural maintenance, it has also resulted in very little structural pressure being exerted on the bridge and also a lack of over-zealous, inappropriate repairs which have compromised many bridges which have remained in heavy use. It is rightly considered as of regional importance with architectural and technical interest but removal of trees and ivy (deep-rooting species) from the top surface and walls of the bridge here should be a priority for its conservation.

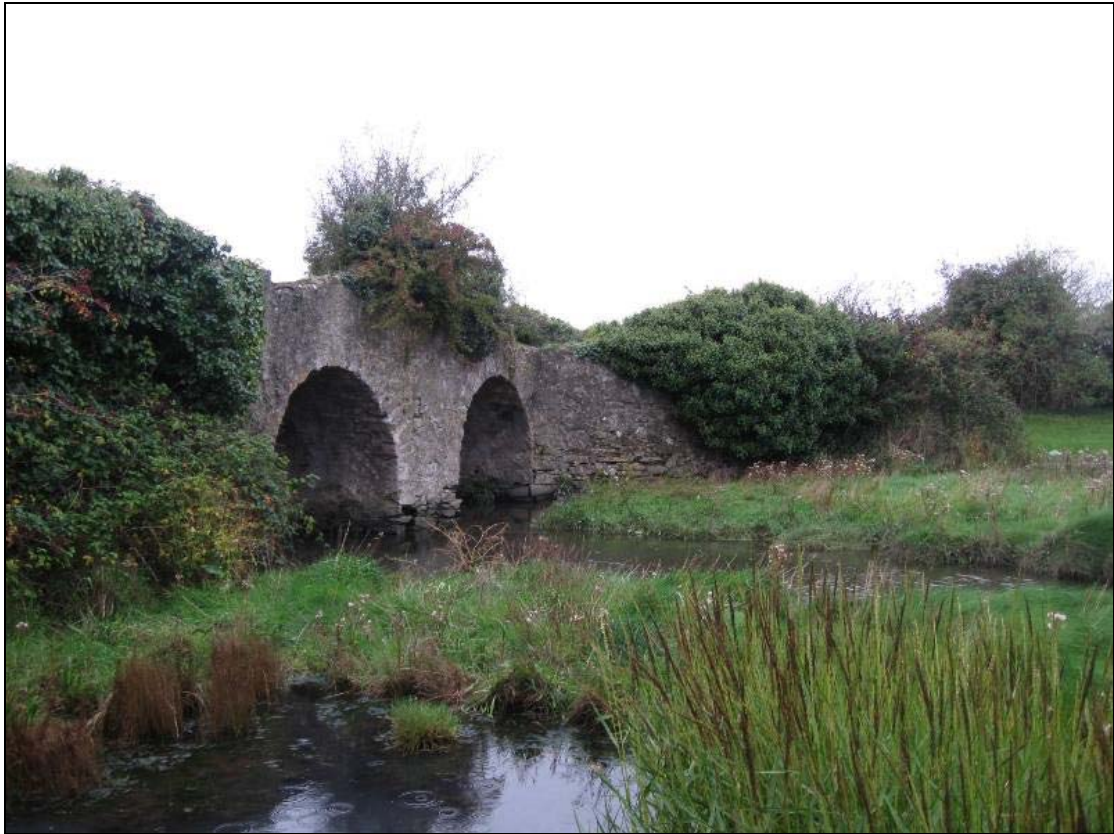
FHBS-10-NH-05 ~ Dense ivy on bridge sidewalls

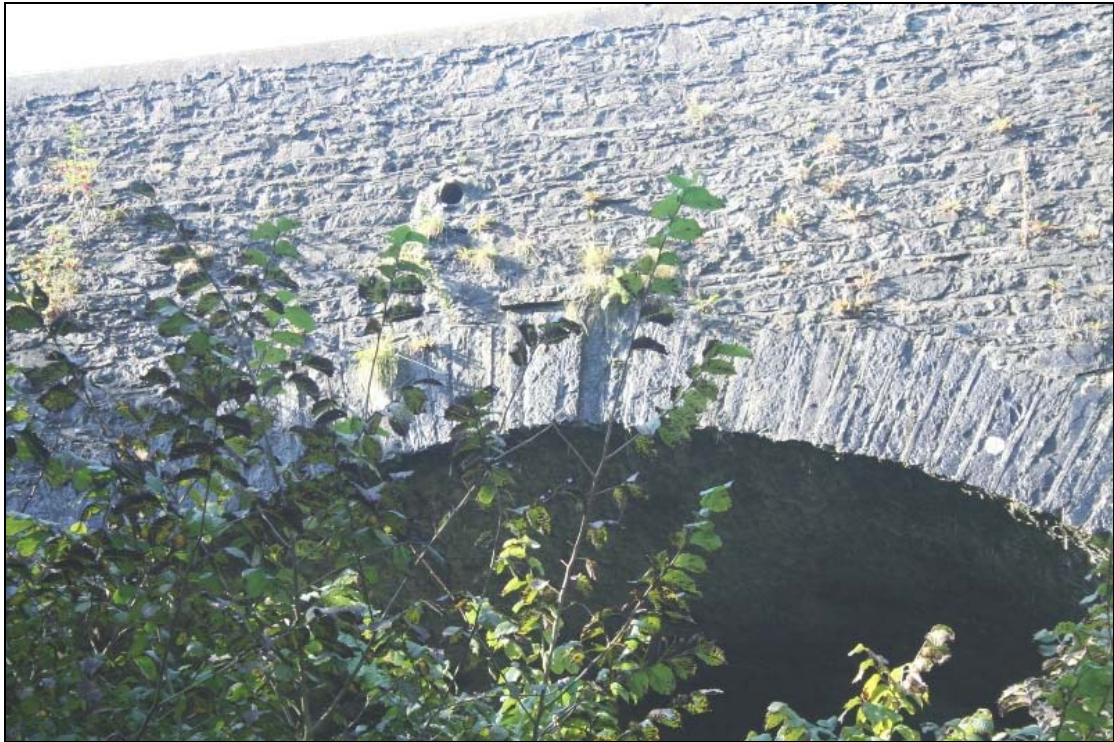
FHBS-11-BH-02 ~ East parapet from east showing road drainage pipe and keystone

- *Protected Structure (under the Local Government (Planning and Development) Act, 2000)
Recorded Monument (under the National Monuments Code)*
- *Repair priorities: - redesign and maintenance of road drainage to prevent contaminated water from washing over the masonry structure

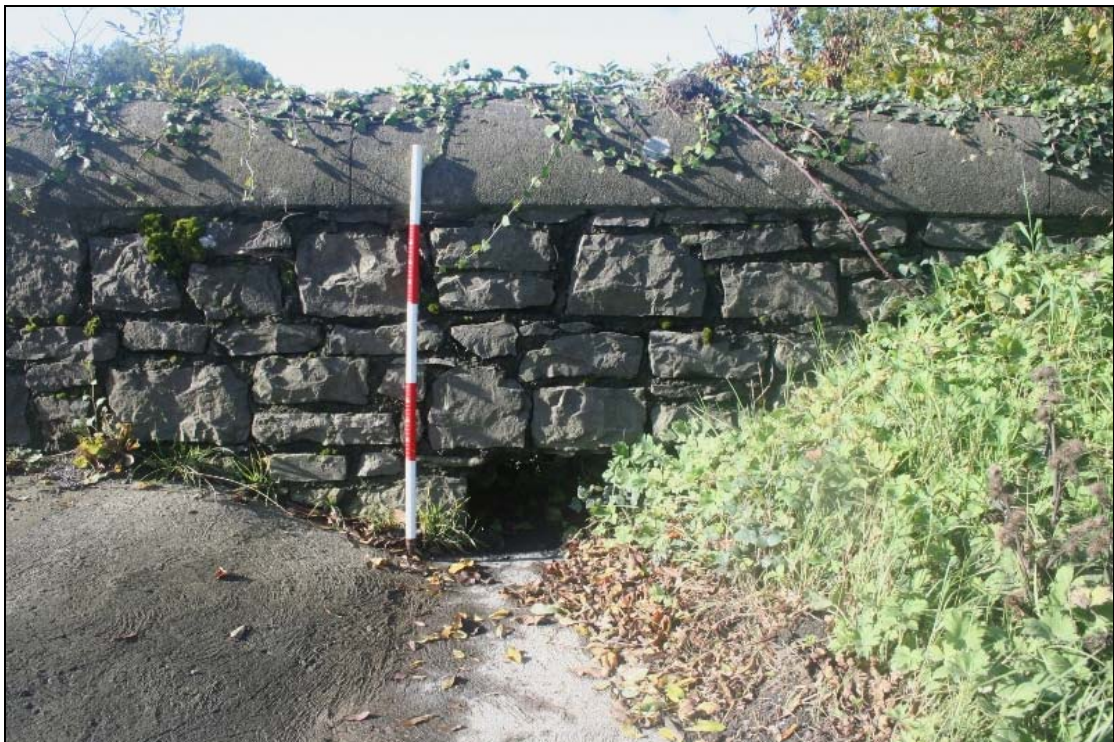
FHBS-11-BH-06 ~ Detail of west parapet masonry and road drainage duct

of all deep-rooted vegetation from the structure and in particular from the corner buttress tops will probably require the masonry on top of the buttresses to be lifted and re-laid using a cement or eminently hydraulic lime mortar to reduce the ingress of water into these parts of the structure. The drainage of the road should also be looked at to ensure that it is directed clear of the historic bridge structure and preferably to a settlement pond or suitable treatment considering the foul nature of the water draining off this busy road.

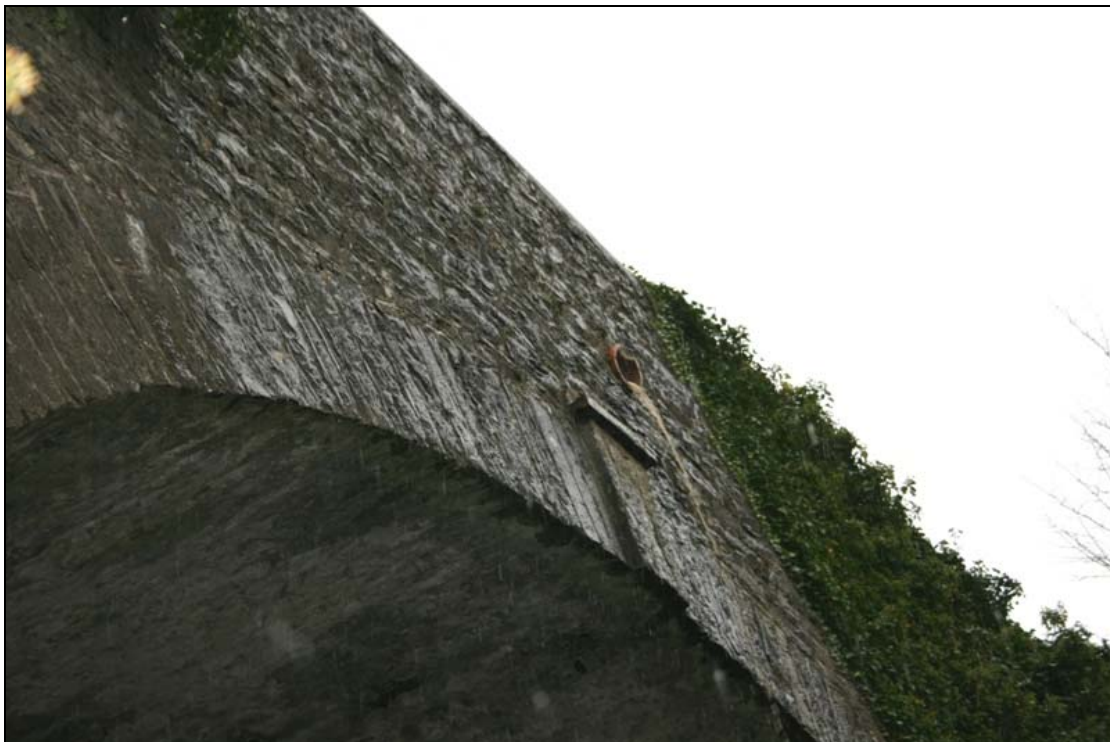
FHBS-11-BH-09 ~ Road drainage through west parapet

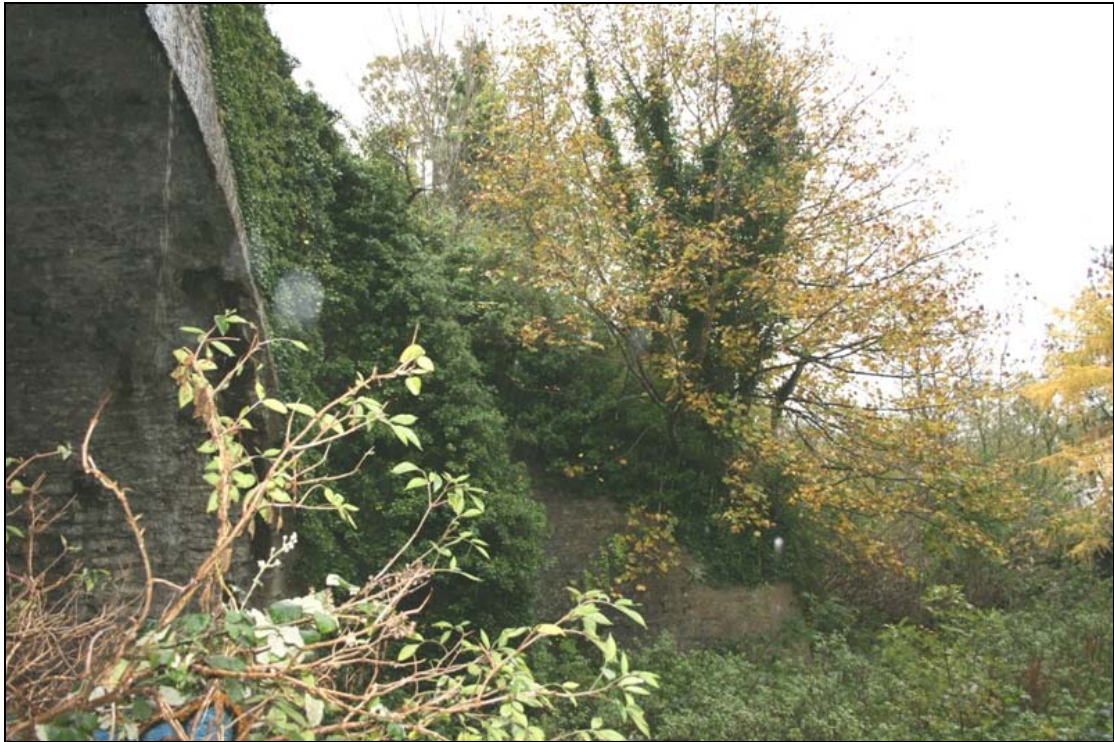
FHBS-11-BH-10 ~ South west buttress with tree and extensive vegetation rooted in masonry

- removal of vegetation rooted on the buttresses
- removal of ivy rooted on masonry, retaining ivy cover as a habitat where no structural damage is being caused*

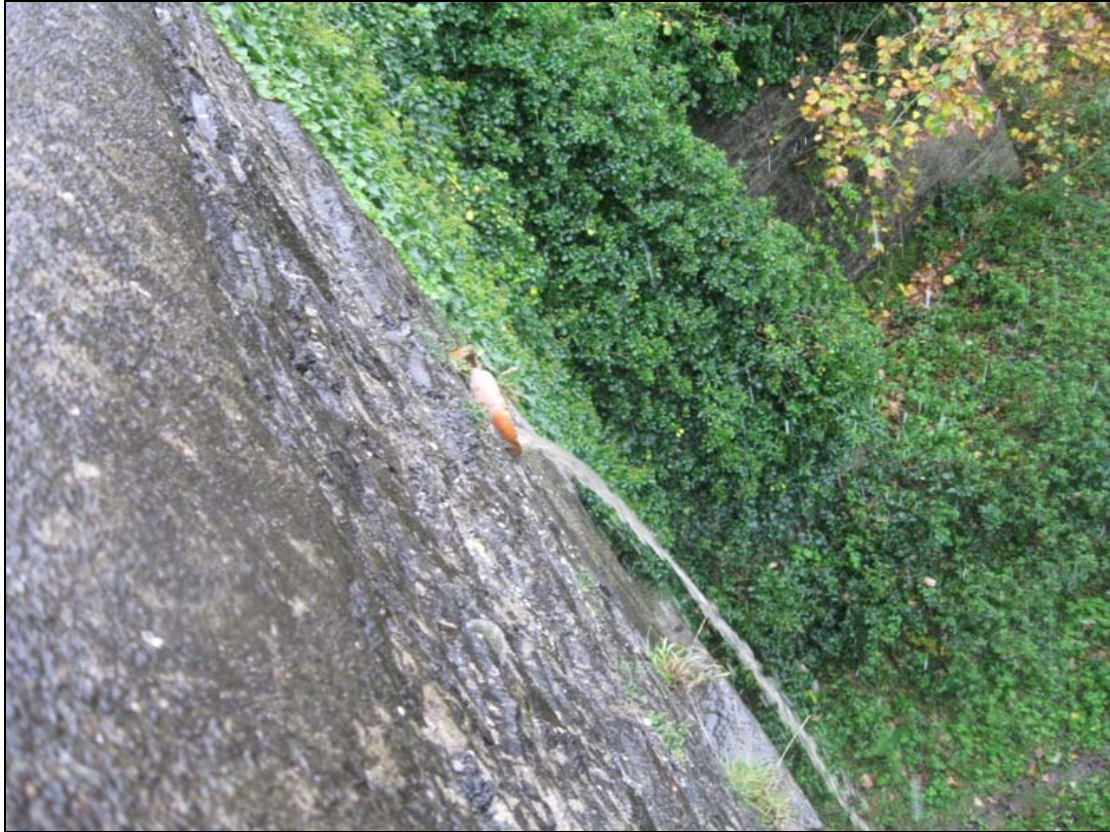
FHBS-11-NH-01 ~ Bridge drainage on upstream parapet wall

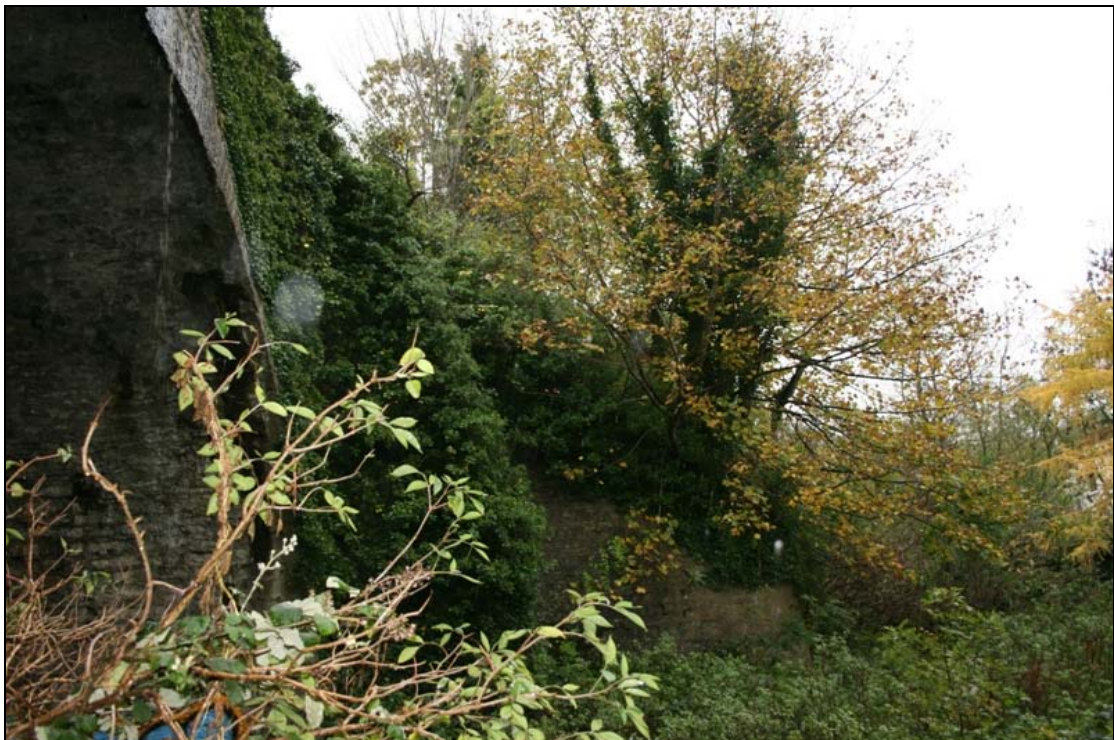
FHBS-11-NH-03 ~ Dense ivy growth on bridge buttress

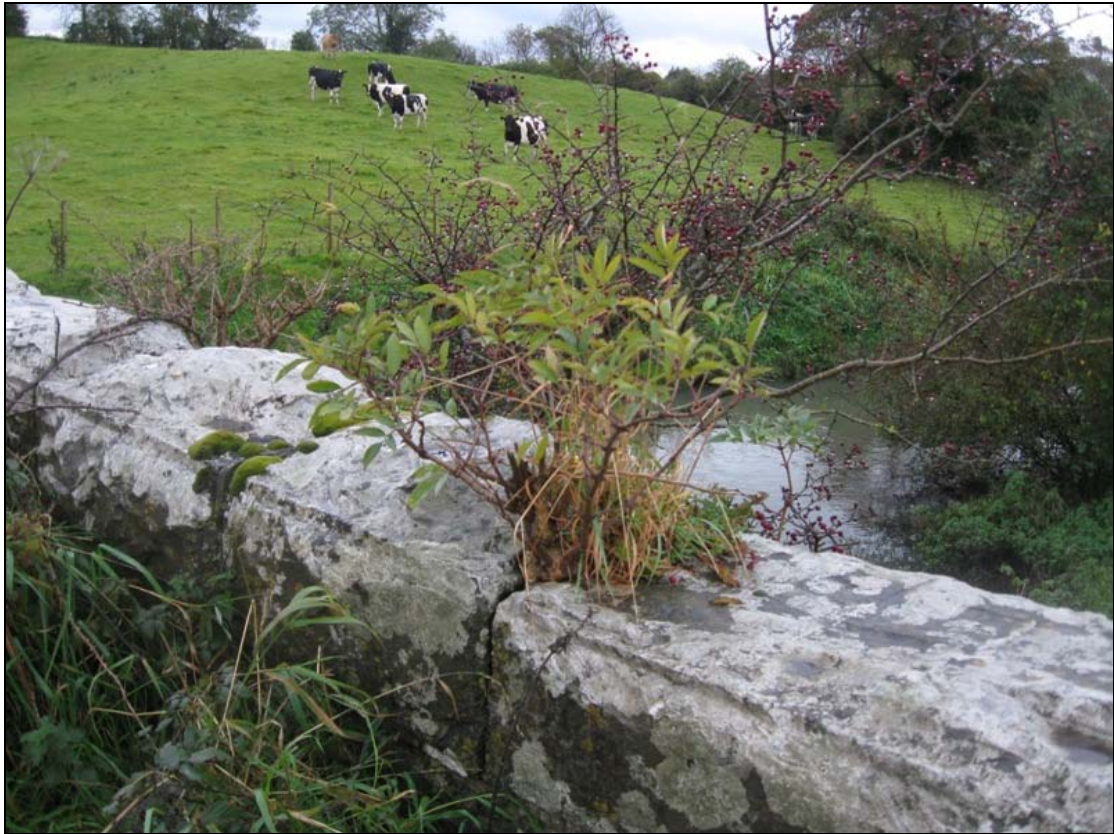
FHBS-12-NH-03 ~ Elder growing on downstream parapet wall

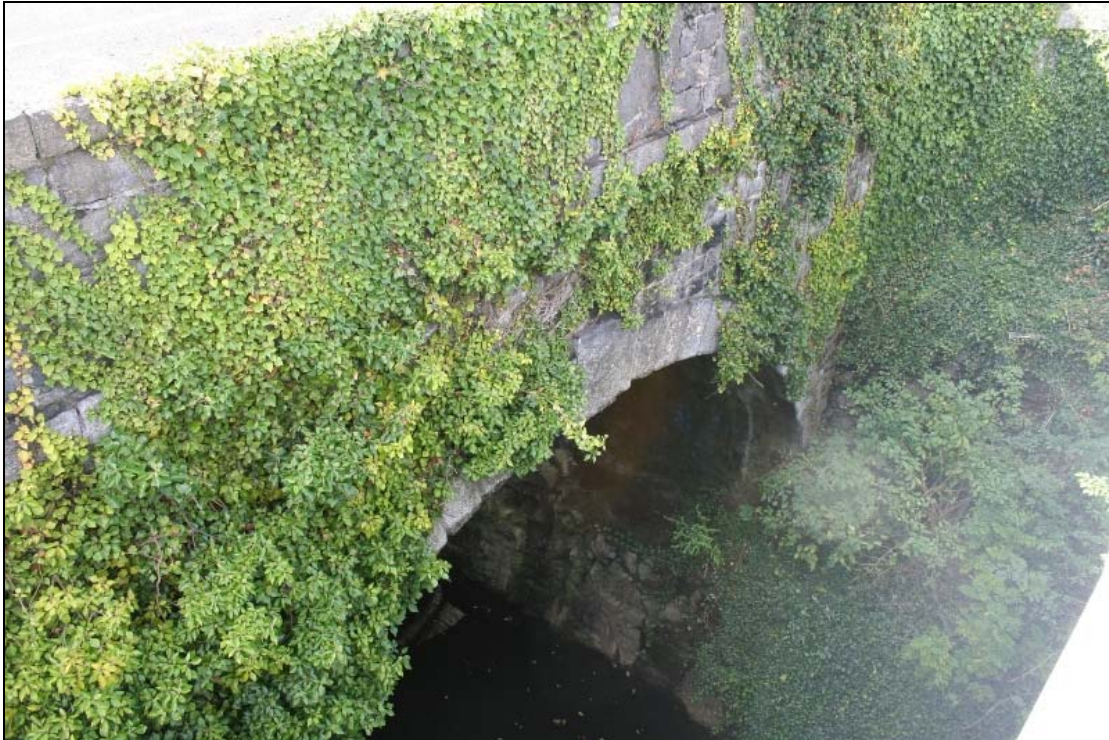
- *Protected Structure (under the Local Government (Planning and Development) Act, 2000)*
- *Extensive ivy growth on the eastern elevation and the lack of access to the west elevation due to extensive tree growth should be addressed by ongoing maintenance programmes retaining ivy cover as a habitat where no structural damage is being caused.*

FHBS-13-BH-01 ~ East elevation from southern end of adjacent footbridge

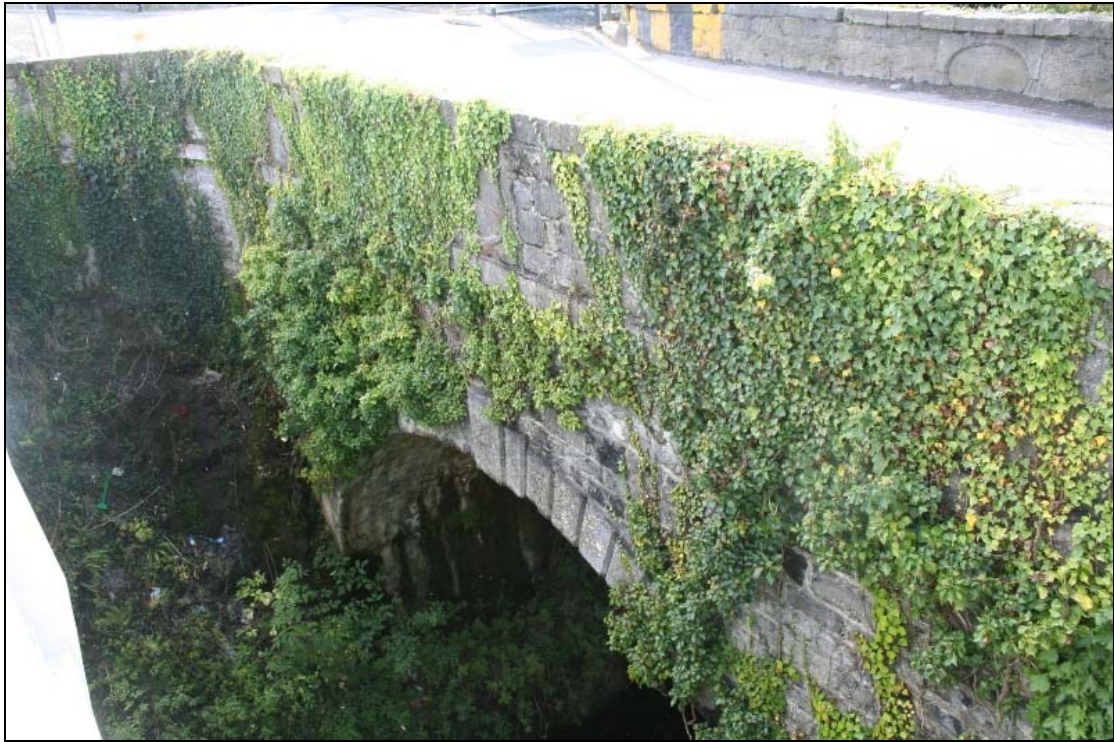
FHBS-13-NH-03 ~ Ivy coverage near bridge underarch

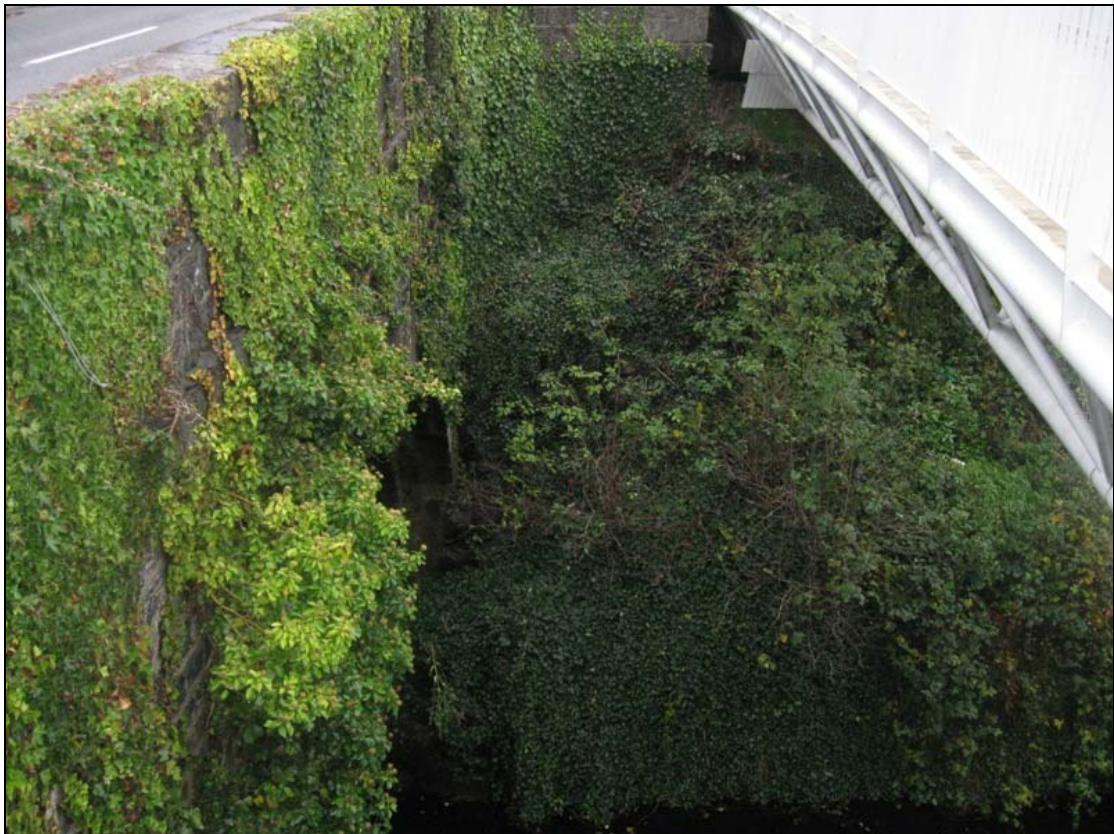
FHBS-13-NH-04 ~ Ivy on downstream parapet wall

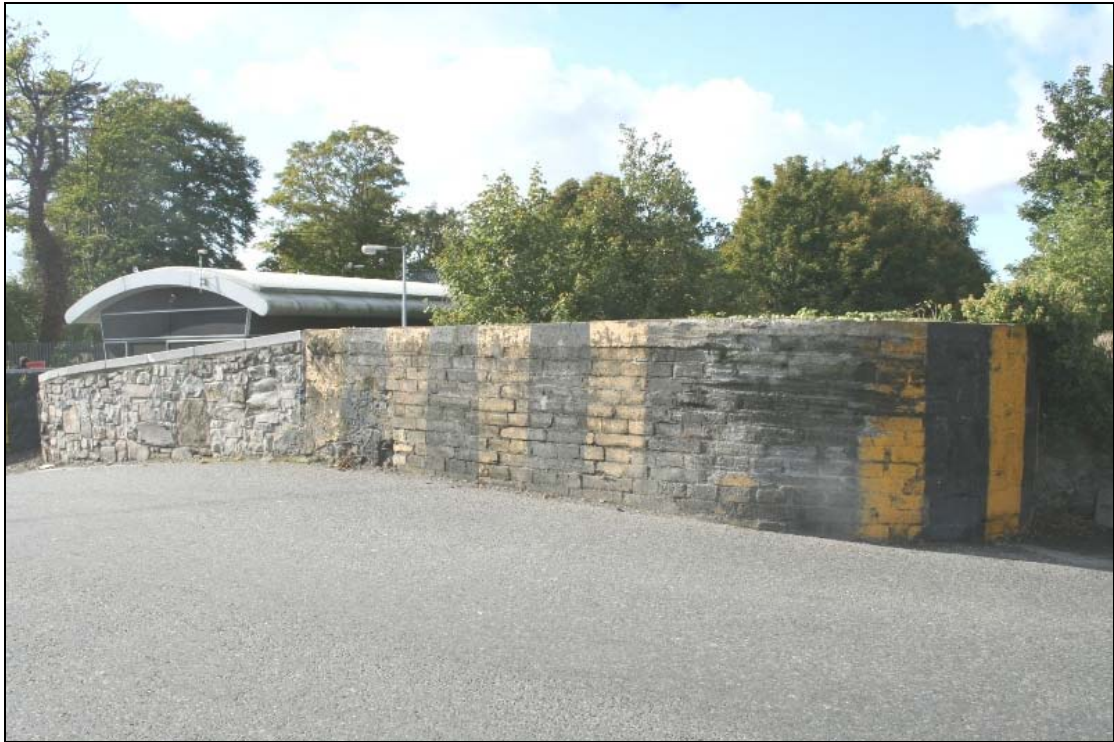
Condition (structural)	Generally good
Condition (parapet)	Poor, especially on the west side which appears to suffer the brunt of road traffic collisions and ad-hoc repairs. The eastern parapet is extensively covered in ivy which made assessment of its condition difficult but its removal would be recommended regardless of the masonry condition. The road side of this eastern parapet contains a steel electricity supply cabinet inserted in the stonework.
Condition (matrix/mortar)	Good although it was noted especially on the wall of the south eastern abutment that a number of stones appear to be of an inferior weathering quality and are crumbling. This is more likely due to poor quality stone rather than inappropriate pointing mortar.
Condition (soffit)	Generally good although some areas towards the crown of the arch would benefit from renewed pointing in lime mortar.
Grouting or spray concrete?	No

FHBS-14-BH-03 ~ West parapet from road

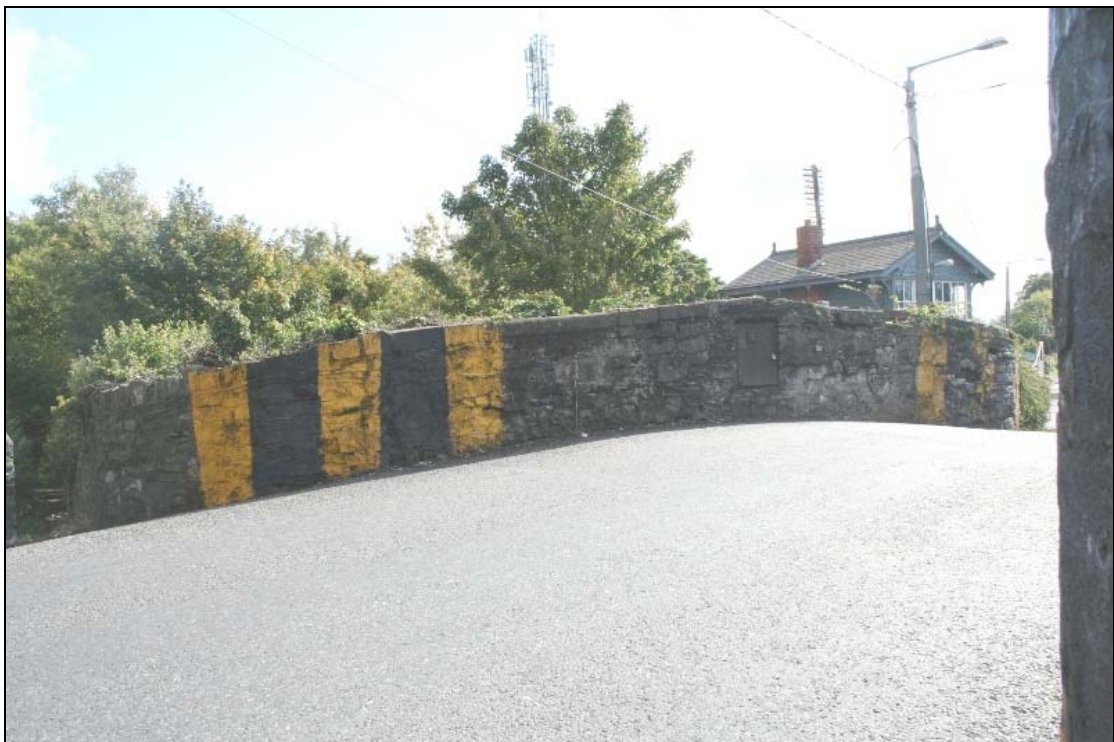
FHBS-14-BH-04 ~ East parapet from road

- *Protected Structure (under the Local Government (Planning and Development) Act, 2000)*
- *Repair priorities: - removal of ivy rooted on masonry, retaining ivy cover as a habitat where no structural damage is being caused
A coordinated management plan should be put in place to consolidate the present structure and ensure that repairs necessary in the future are effected with greater regard for the architectural significance of this protected structure.*

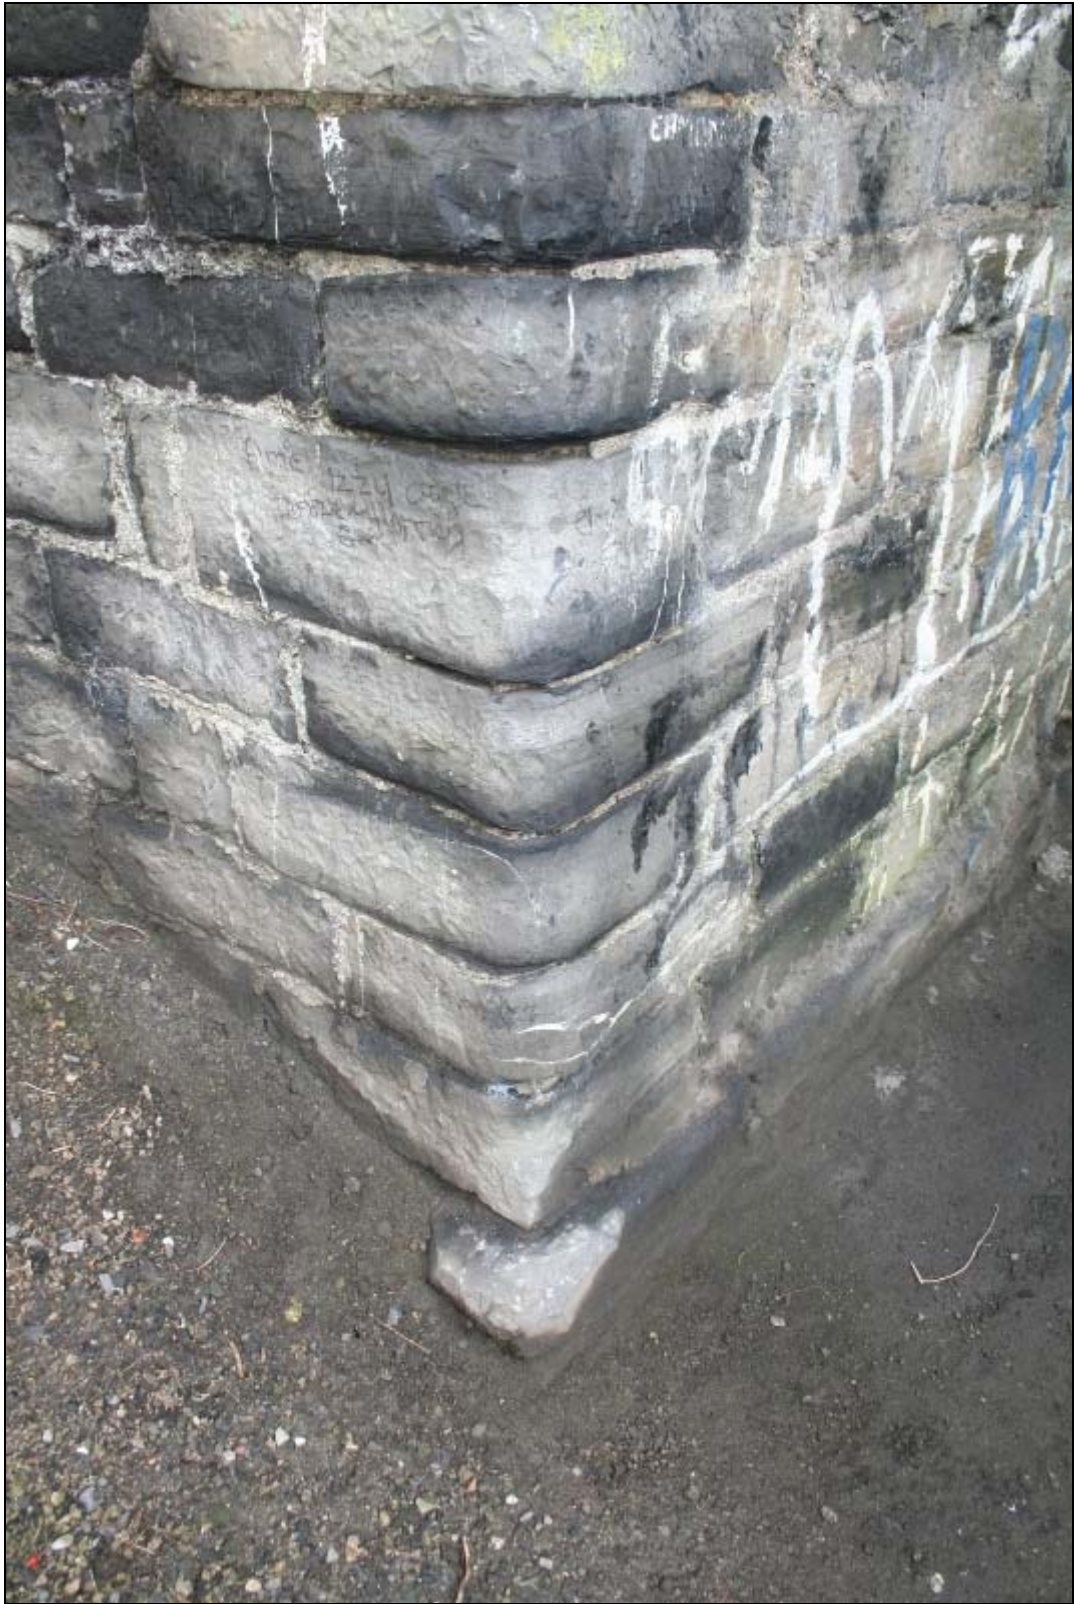
FHBS-14-BH-06 ~ Rounded arris to masonry beside towpath.

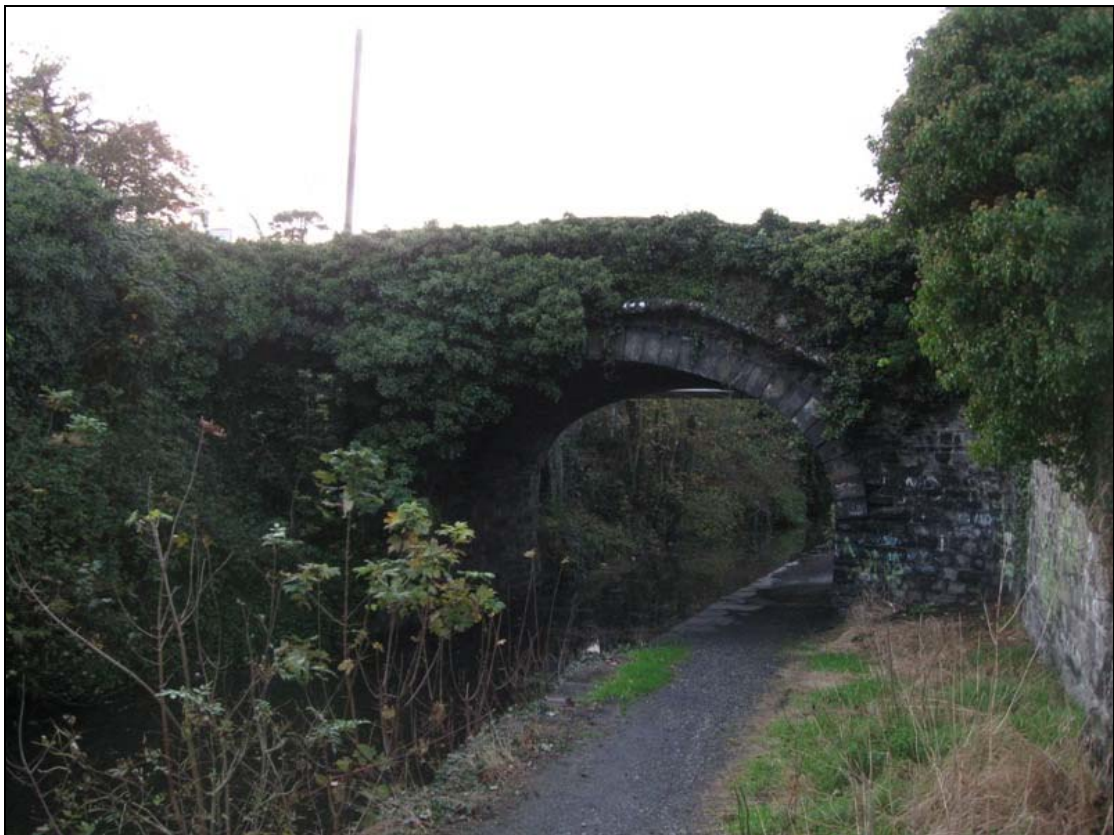
FHBS-14-NH-02 ~ Ivy coverage on bridge parapet wall

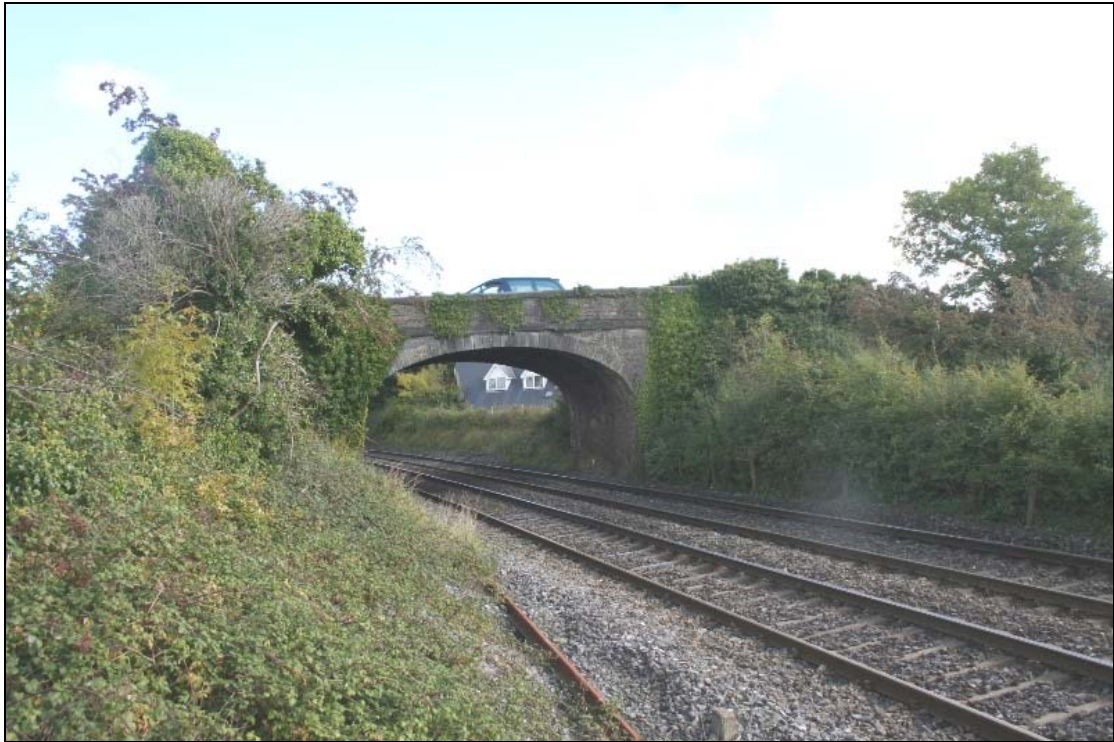
FHBS-15-BH-11 ~ West elevation of rail bridge

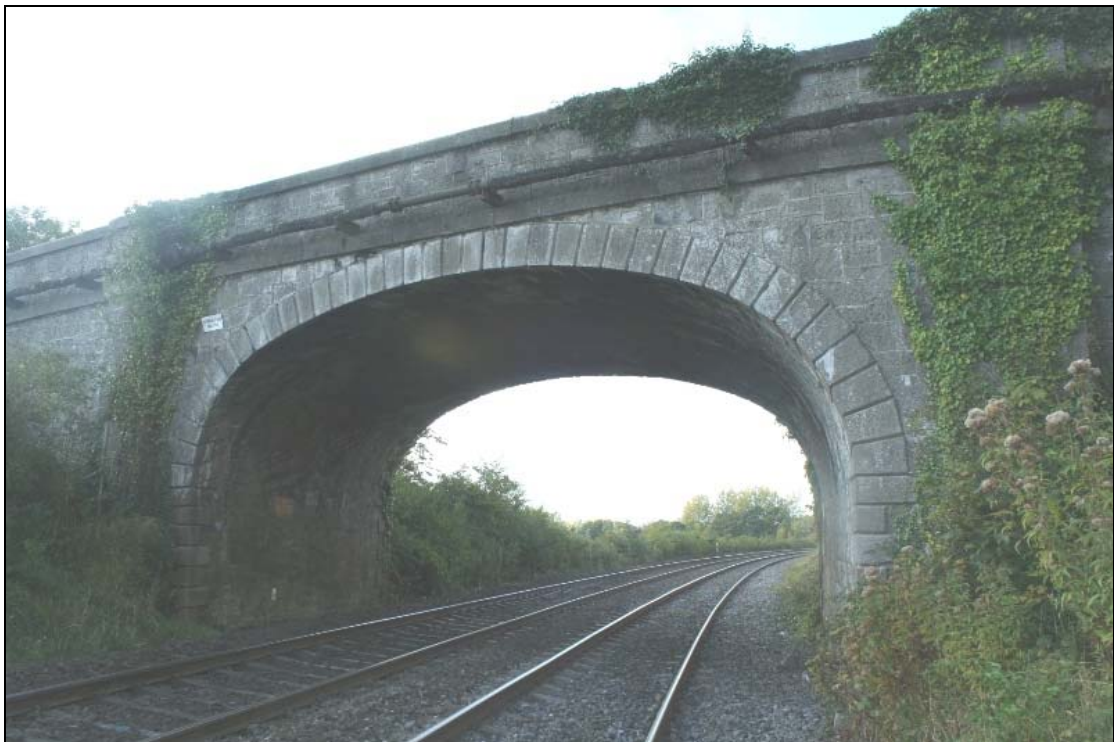
FHBS-15-BH-12 ~ East elevation of rail bridge

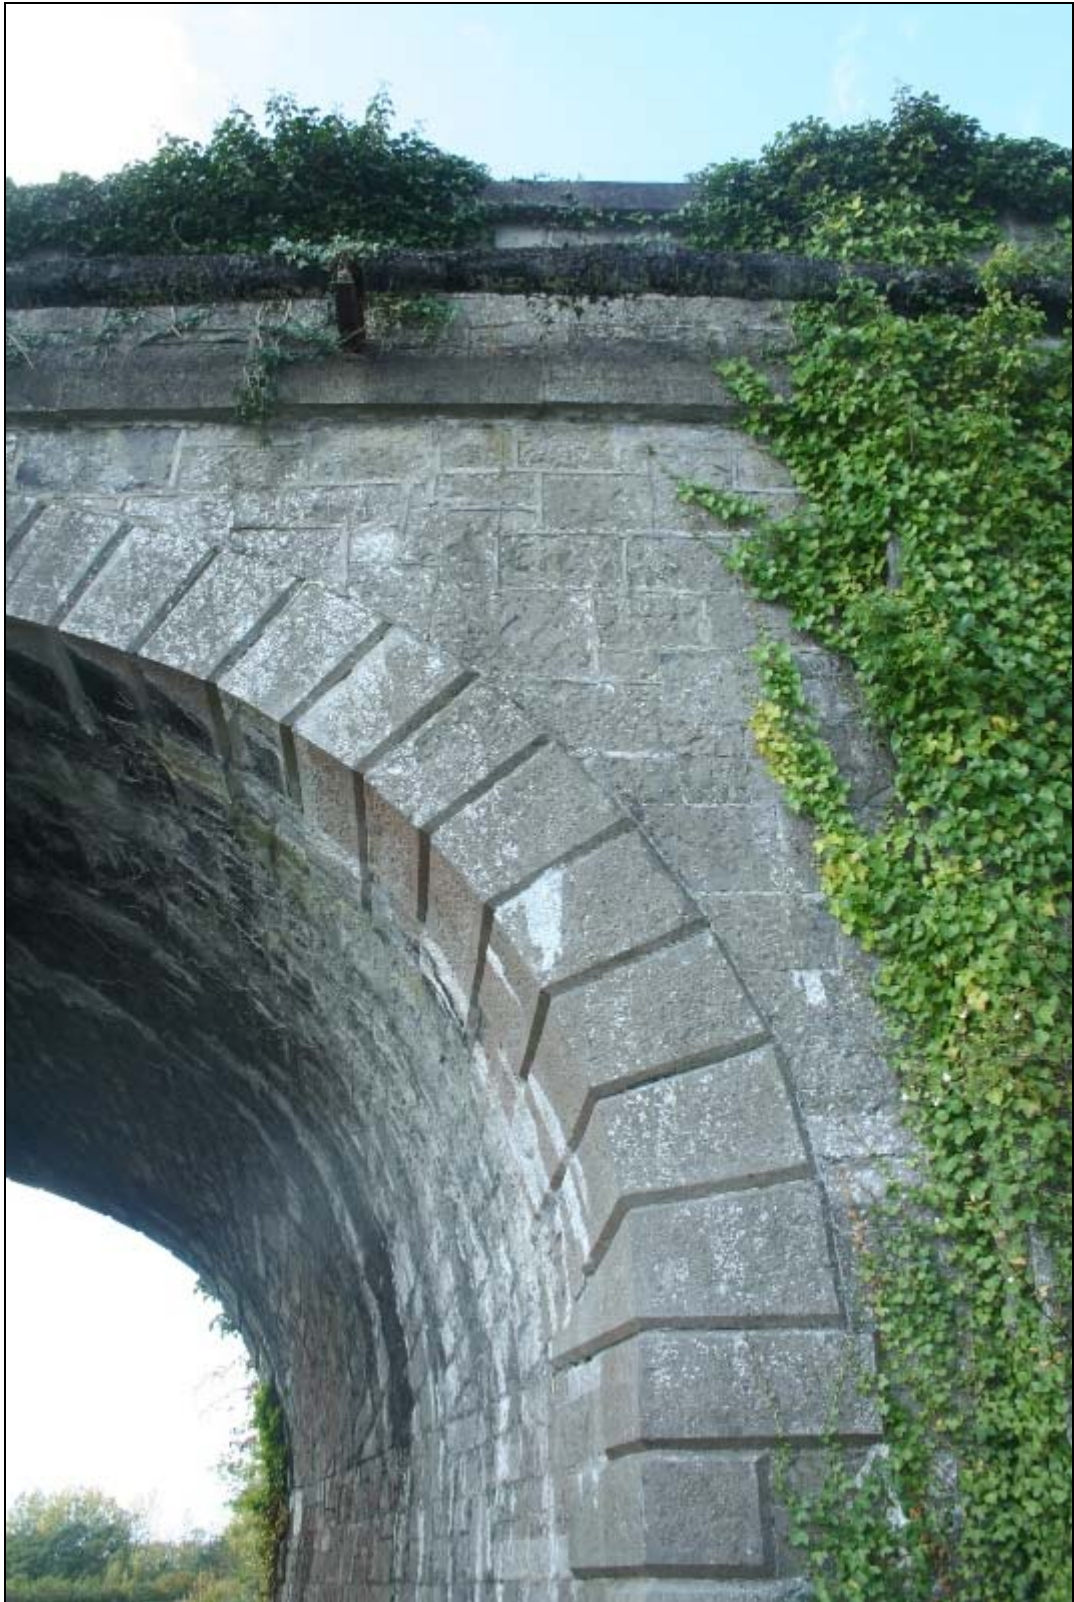
FHBS-15-BH-13 ~ Detail of north east corner of rail bridge

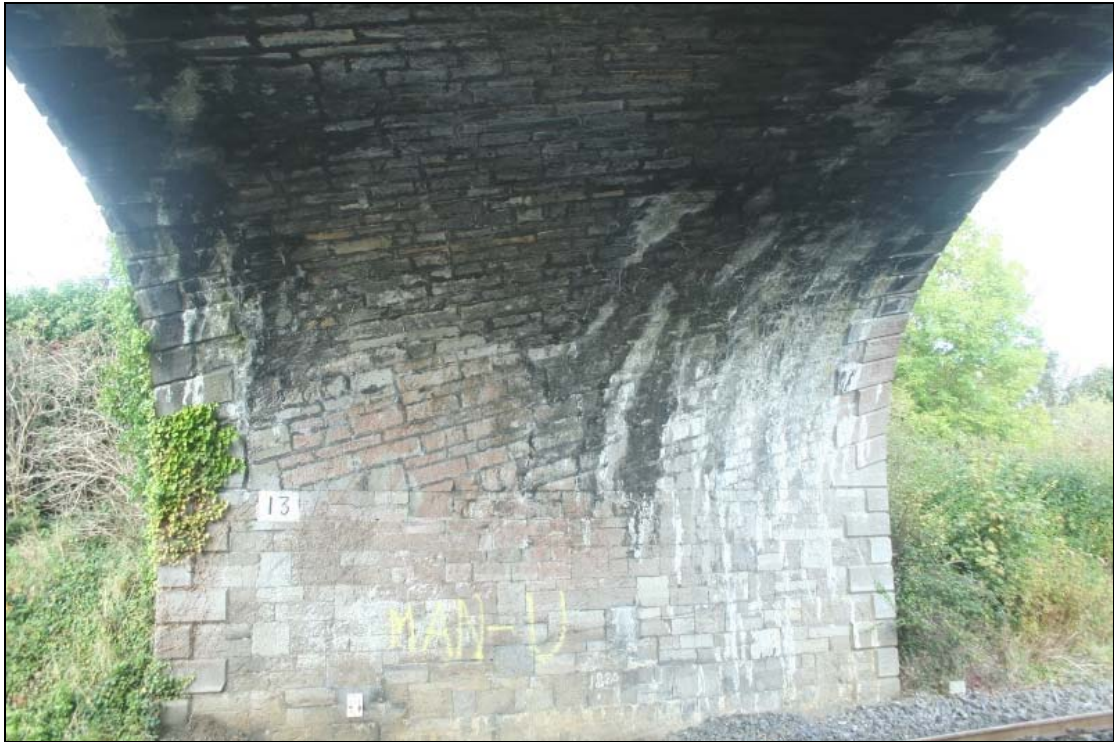
FHBS-15-BH-14 ~ South side of rail bridge's skewed arch soffit

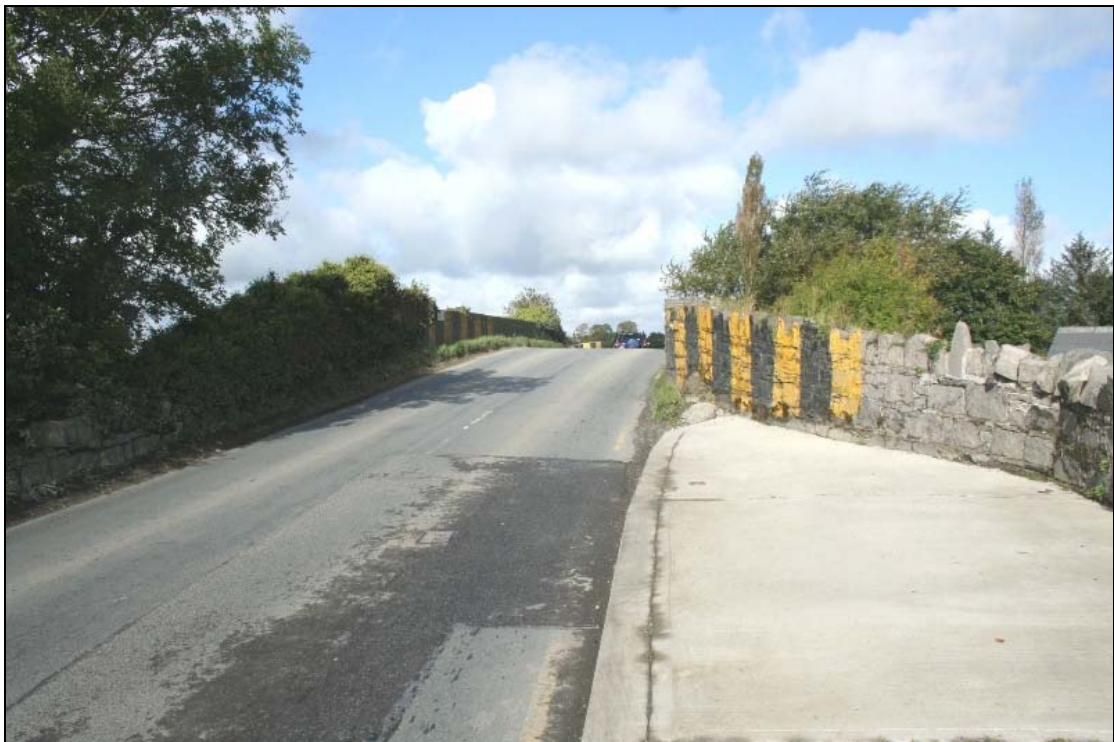
FHBS-15-BH-15 ~ View north over rail bridge)

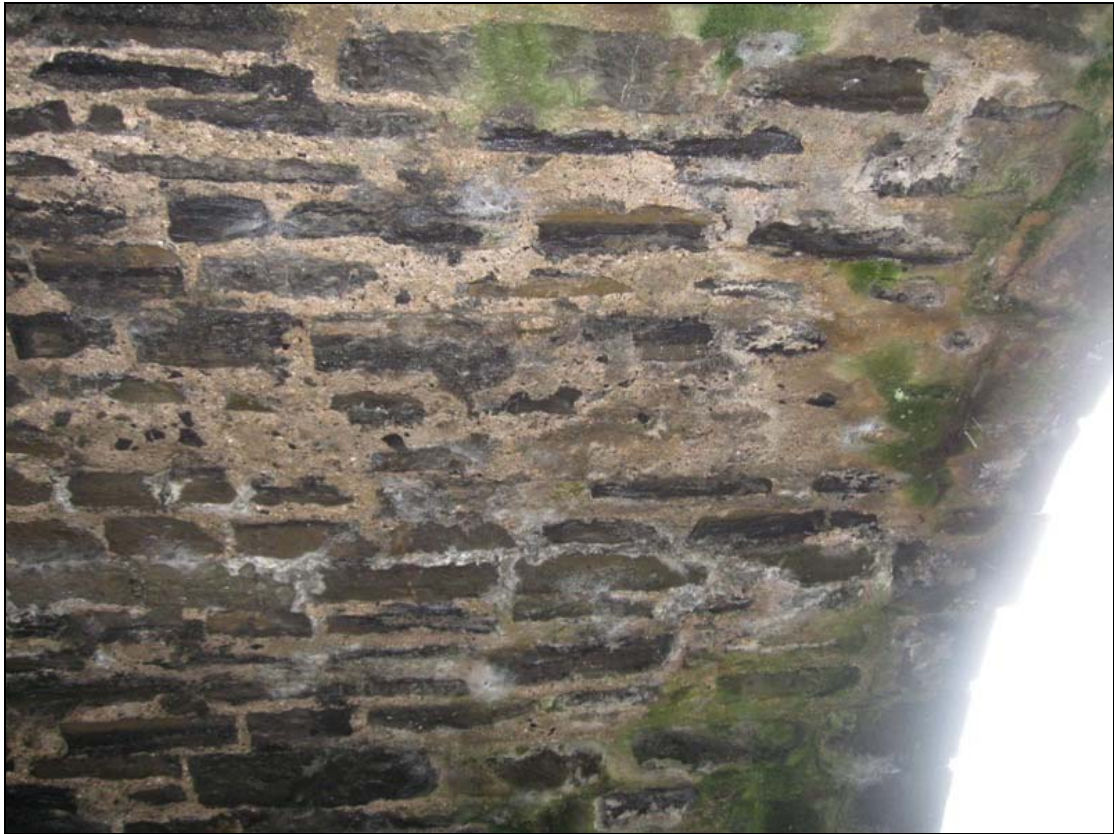
FHBS-15-NH-01 ~ Bridge underarch

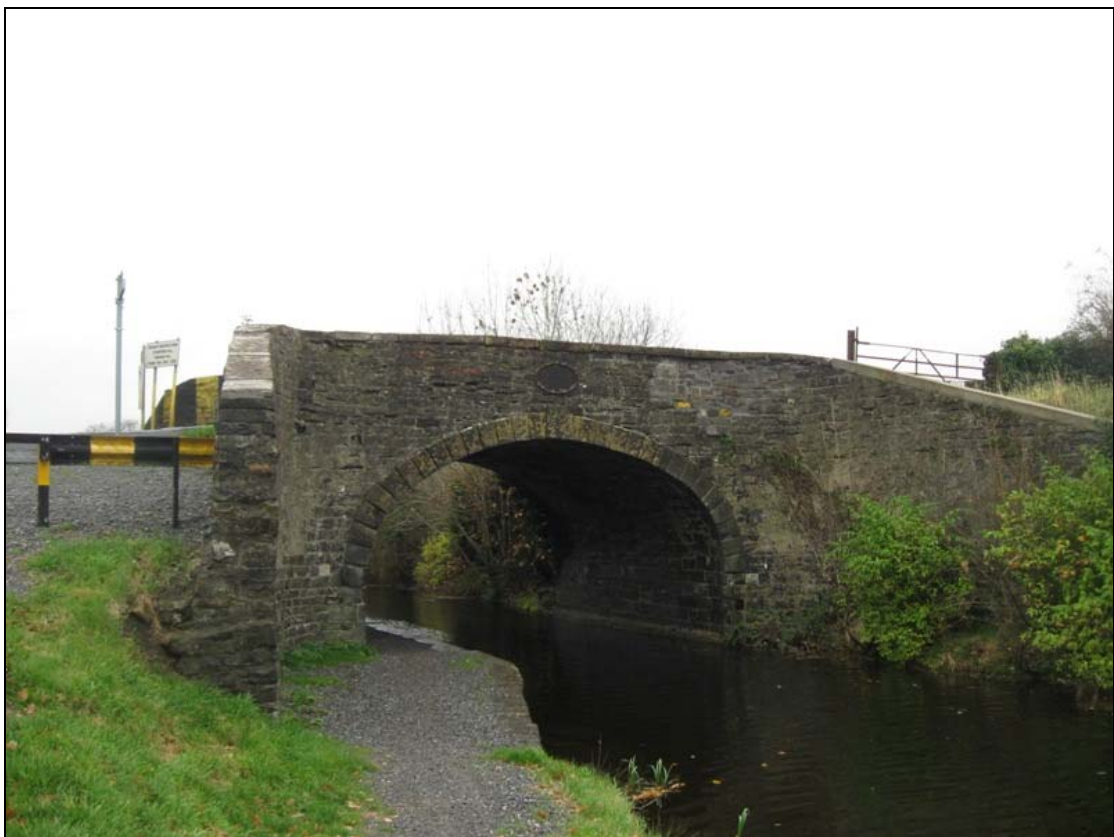
FHBS-15-NH-04 ~ Upstream side of bridge structure
